## 屏東縣歷史災情紀錄表

| 回報日期：115 年 08 月 24 日 08:56 | | 災情類別：水利設施災情（豪雨事件） |
| 地點：九如鄉玉泉街 18 巷附近 | | 回報人員：EMIC／九如鄉公所回報 |

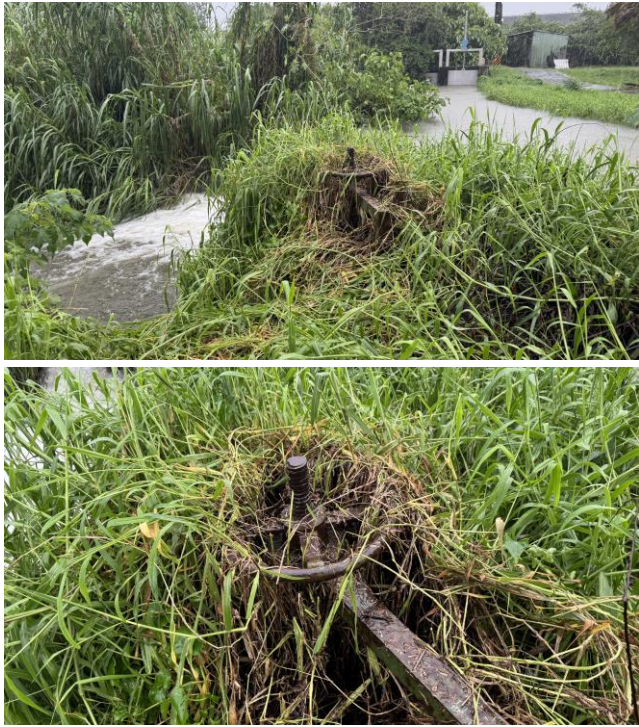
| 回報日期：115 年 08 月 24 日 08:56 | | 災情類別：水利設施災情（豪雨事件） |
|---|---|---|
| 1 | 水閘門長年鎖住，排水逆流進農地。 | <p>The first photograph shows a concrete water gate structure completely blocked by a dense growth of tall green grass and weeds. Water is visible flowing through the narrow opening behind the gate. The second photograph is a close-up of the gate's mechanism, showing a metal handle and a wooden beam, both heavily overgrown with thick vegetation, preventing the gate from being opened.</p> |
